# Case Study 2 - PCBA

## ❑ Background

- ❑ Customer wants to reuse their fast moving existing design where 3 types of 4PDT Relays were obsolete

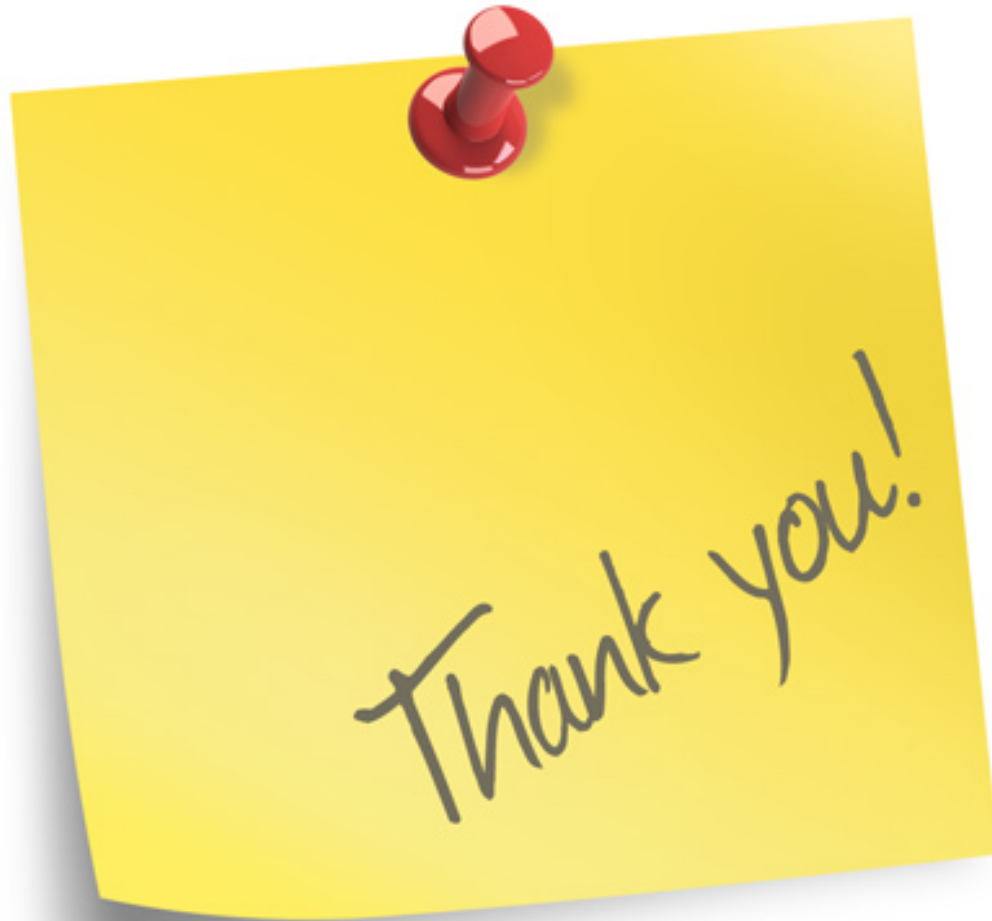
- ❑ As all MFRs discontinued 4PDT Relays, Suggested DPDT Relay as replacement with a minor design change.
- ❑ Each 4PDT Relay replaced by 2 No X DPDT + a Coil Protection Diode.

On Time Delivery with new solution (with addition of 106 parts in place of 39 parts within the same space), completed in a cycle time of 14 working days.
